DEPARTMENT OF THE ARMY  
ARMY CONCEPT TEAM IN VIETNAM  
APO San Francisco 96384

2 FEB 1970

SUBJECT: Final Letter Report - Night Flying Control System for UH-1

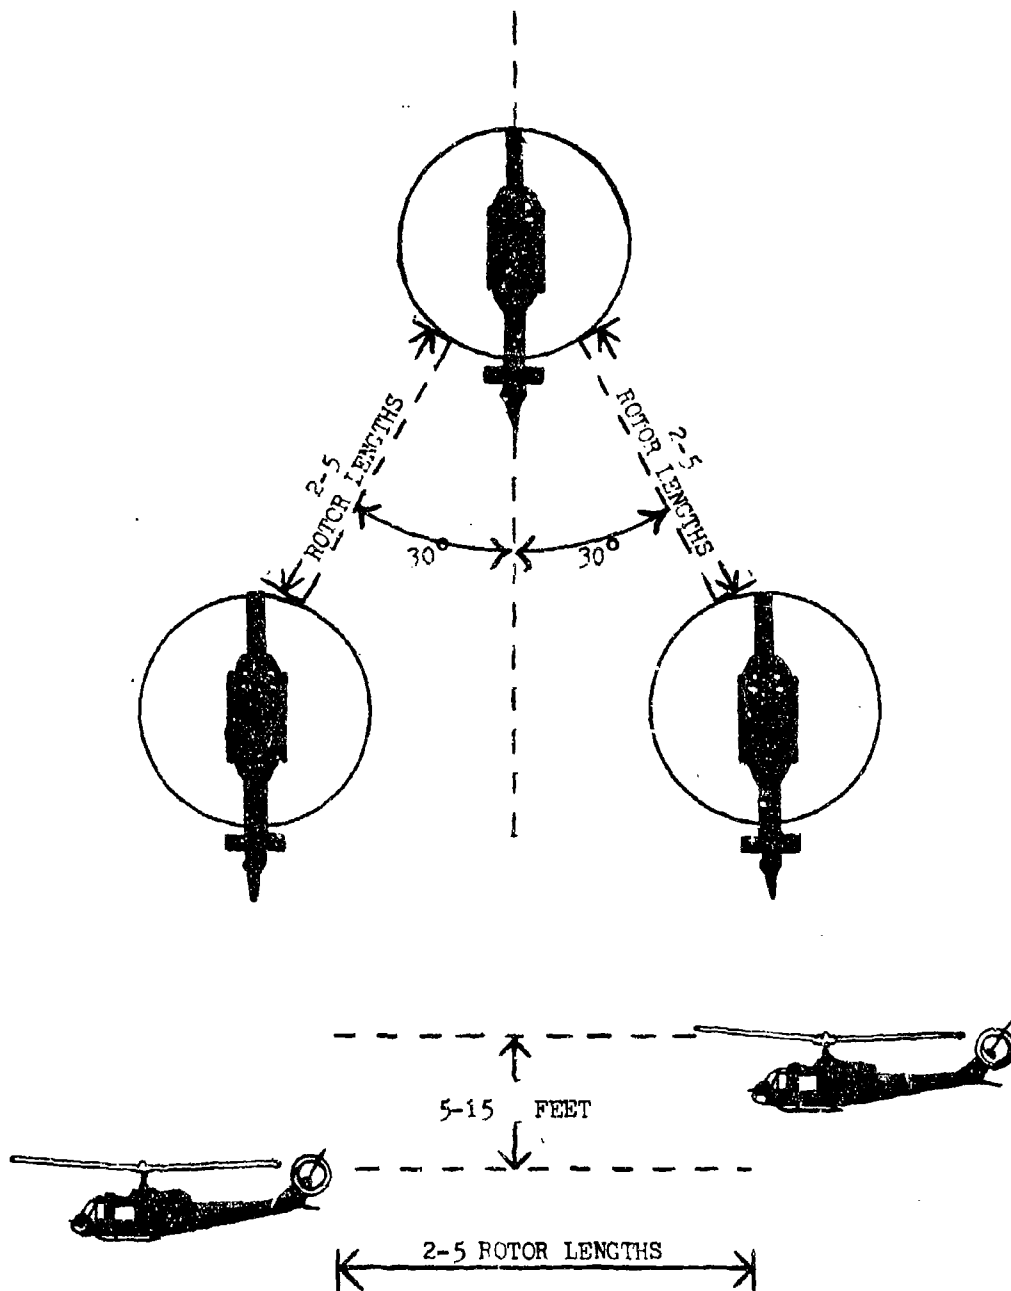
FIGURE 2.

(a) The 117th AHC performed nightly "Firefly" missions which consisted of one UH-1H equipped with the NFCS and two UH-1C escort aircraft. This unit evaluated the system by flying with the escort aircraft in close "V" formation enroute to and on return from the operational area. (Figure 2) While in operational area a loose trail formation with 500-1,000 meters separation was flown.

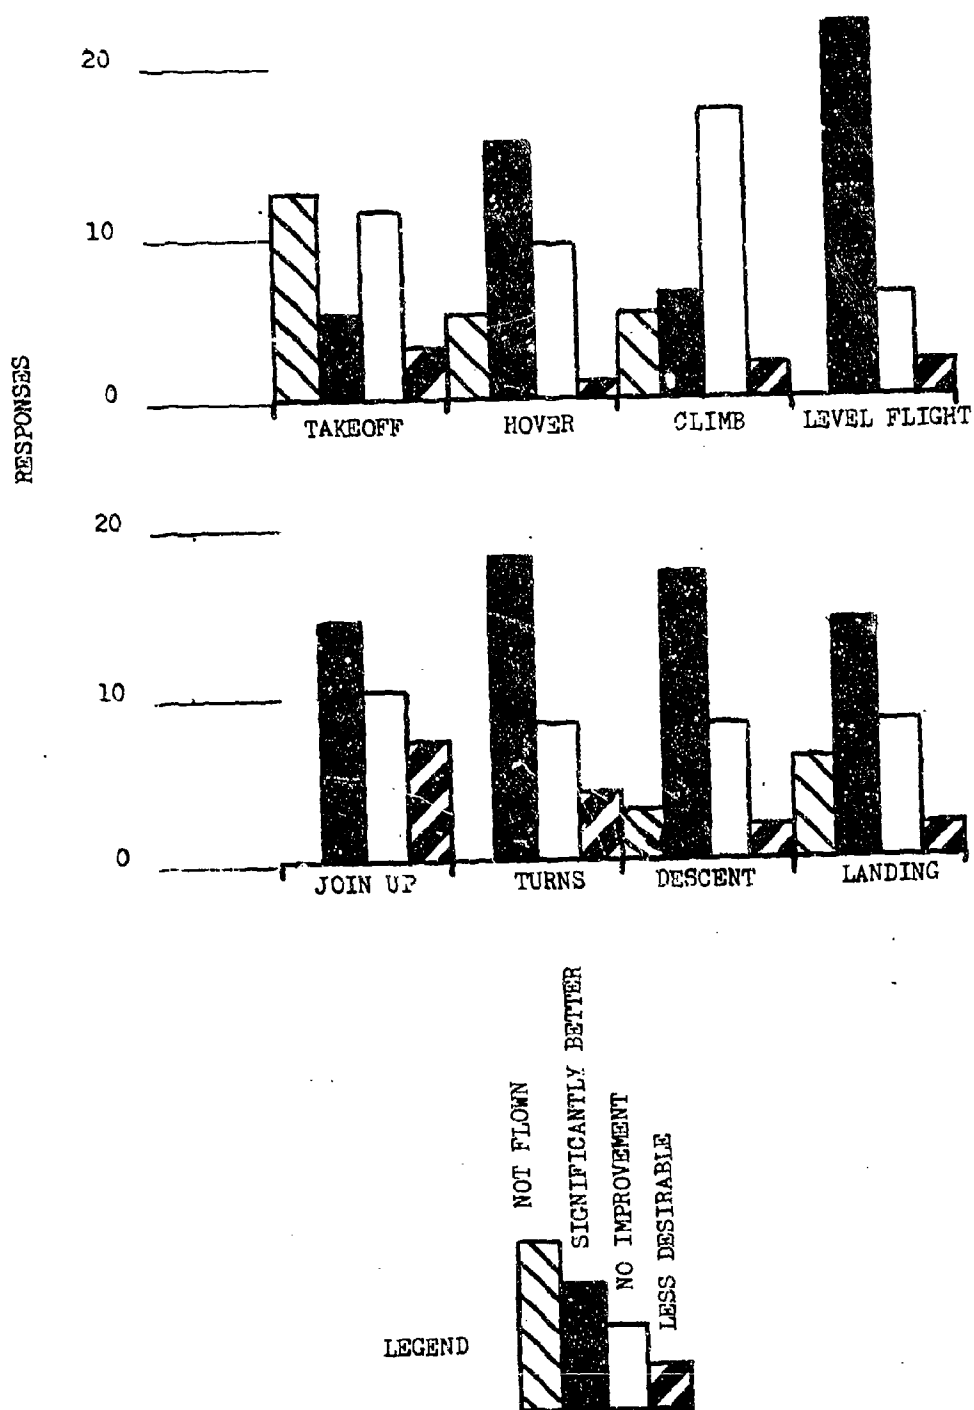
(4) Figure 3 graphically illustrates pilots' opinions of the NFCS. During takeoff and climb the NFCS lights were difficult to see until the trailing aircraft were able to climb to a position level with or above number 1. Responses were particularly favorable during level flight. Pilots stated that the slightest control movement could be detected by observing the change in the rotor tip pattern.

FIGURE 3. Summary of Pilot responses
